Redwood Tree/Recycled Water Study

Dublin Sports Park and Emerald Glen Park

PREPARED FOR:
City of Dublin
100 Civic Plaza
Dublin, CA 94568

PREPARED BY:
HortScience, Inc.
2150 Rheem Dr., Suite A
Pleasanton, CA 94588

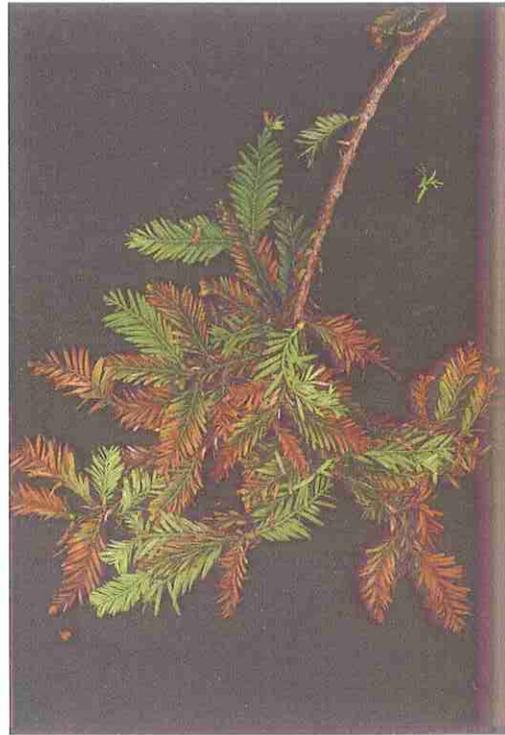
Tree #173 was located in a planting strip along the south side of the park between the turf and the soundwall along highway 580 (see Table 2). The canopy was thinning so that the trunk was visible through the foliage and the overall coloration of the tree was brownish. There was tip necrosis and needle browning on the current and previous year's growth. The ivy groundcover at the base of the tree combined with needles and cones that had fallen to the ground which formed a thick, loose mat over the tree roots. The ivy was growing up the trunk approximately two feet, and the crown of the tree was raised to nine feet with branches hanging down to three feet. The irrigation stains on the trunk were up to and wetting low hanging foliage. The soil was moist. The condition rating of tree #173 was poor (see Photo 1).

Photo 1. The leaflet above illustrates a poor tree condition rating where 50% of the needles on the leaflet are dead. Notice the several stages of leaf necrosis from tip browning to partial yellowing and finally to complete leaflet necrosis.

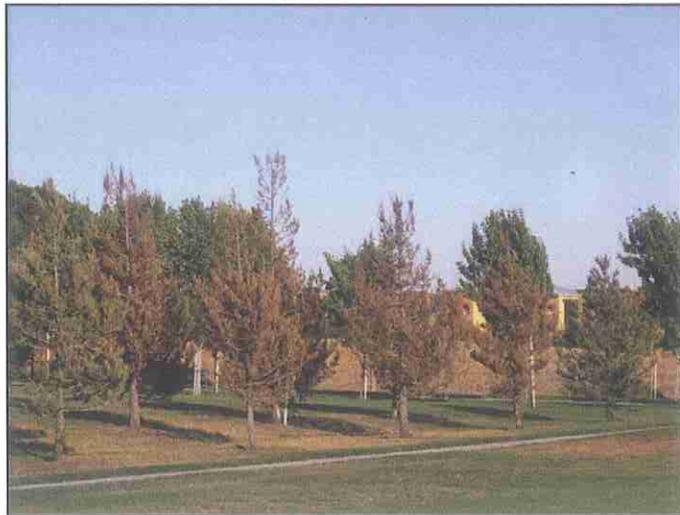
Tree #177 was brownish-green in overall color, as were the other trees in the area. The trunk was visible through the canopy and there was thinning at the top of the crown. There was loss of needles on branch segments, and necrosis on previous year and current year's growth,

Photo 2. Redwood tree #177, and the trees adjacent to it, were brownish-green in overall color, and the turfgrass underneath them was sparse and dry.

especially around the base of the tree from sprinkler wetting. The turfgrass in the area was sparse and the ground was dry as can be seen in Photo 2. The condition of this tree was poor.

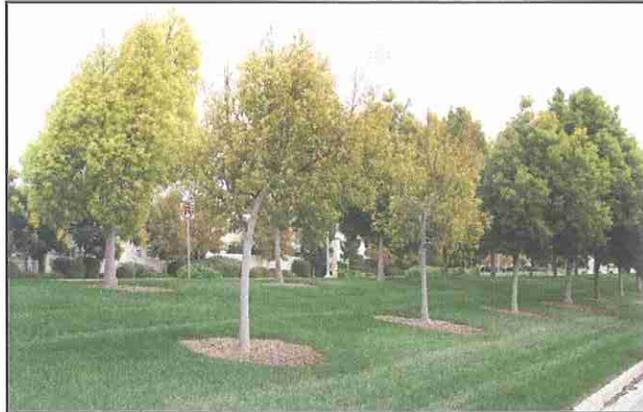
On the north side of Emerald Glen Park along Gleason Drive, camphor trees were planted in a turfgrass berm that slopes from street level to a parking lot. Throughout the study area, the soil was moist and there was no evidence of runoff or standing water. The trees were observed in various stages of vigor and declining health ranging from thick foliage and deep green canopies, to yellowing foliage and branch dieback (see Photo 3). All three trees were described, photographed and mapped (see Exhibit 1).

Photo 3. Camphor trees were observed in varying stages of decline as exhibited by the variation in foliage from deep green to chlorotic yellow. The tree in the foreground had several dead branches in the canopy.

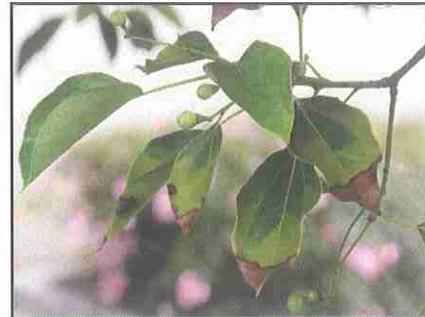
Upon close inspection of tree #2 it was observed that there was evidence of a progressive necrosis of the leaf beginning at the tip and spreading to a mottled or chlorotic condition between lateral veins and the midribs (see Photo 4). This condition worsened as the leaves died and fell off, leading to the eventual dieback of the stem.

Photo 4. Camphor leaves exhibiting progressive necrosis.
