**GEOLOGIC HAZARDS EVALUATION  
AND  
PRELIMINARY GEOTECHNICAL ENGINEERING STUDY**

**Faria Preserve  
San Ramon  
Contra Costa County, California**

**OCTOBER 2004**

**EARTH SYSTEMS CONSULTANTS  
Northern California  
47853 Warm Springs Boulevard  
Fremont, California 94539**

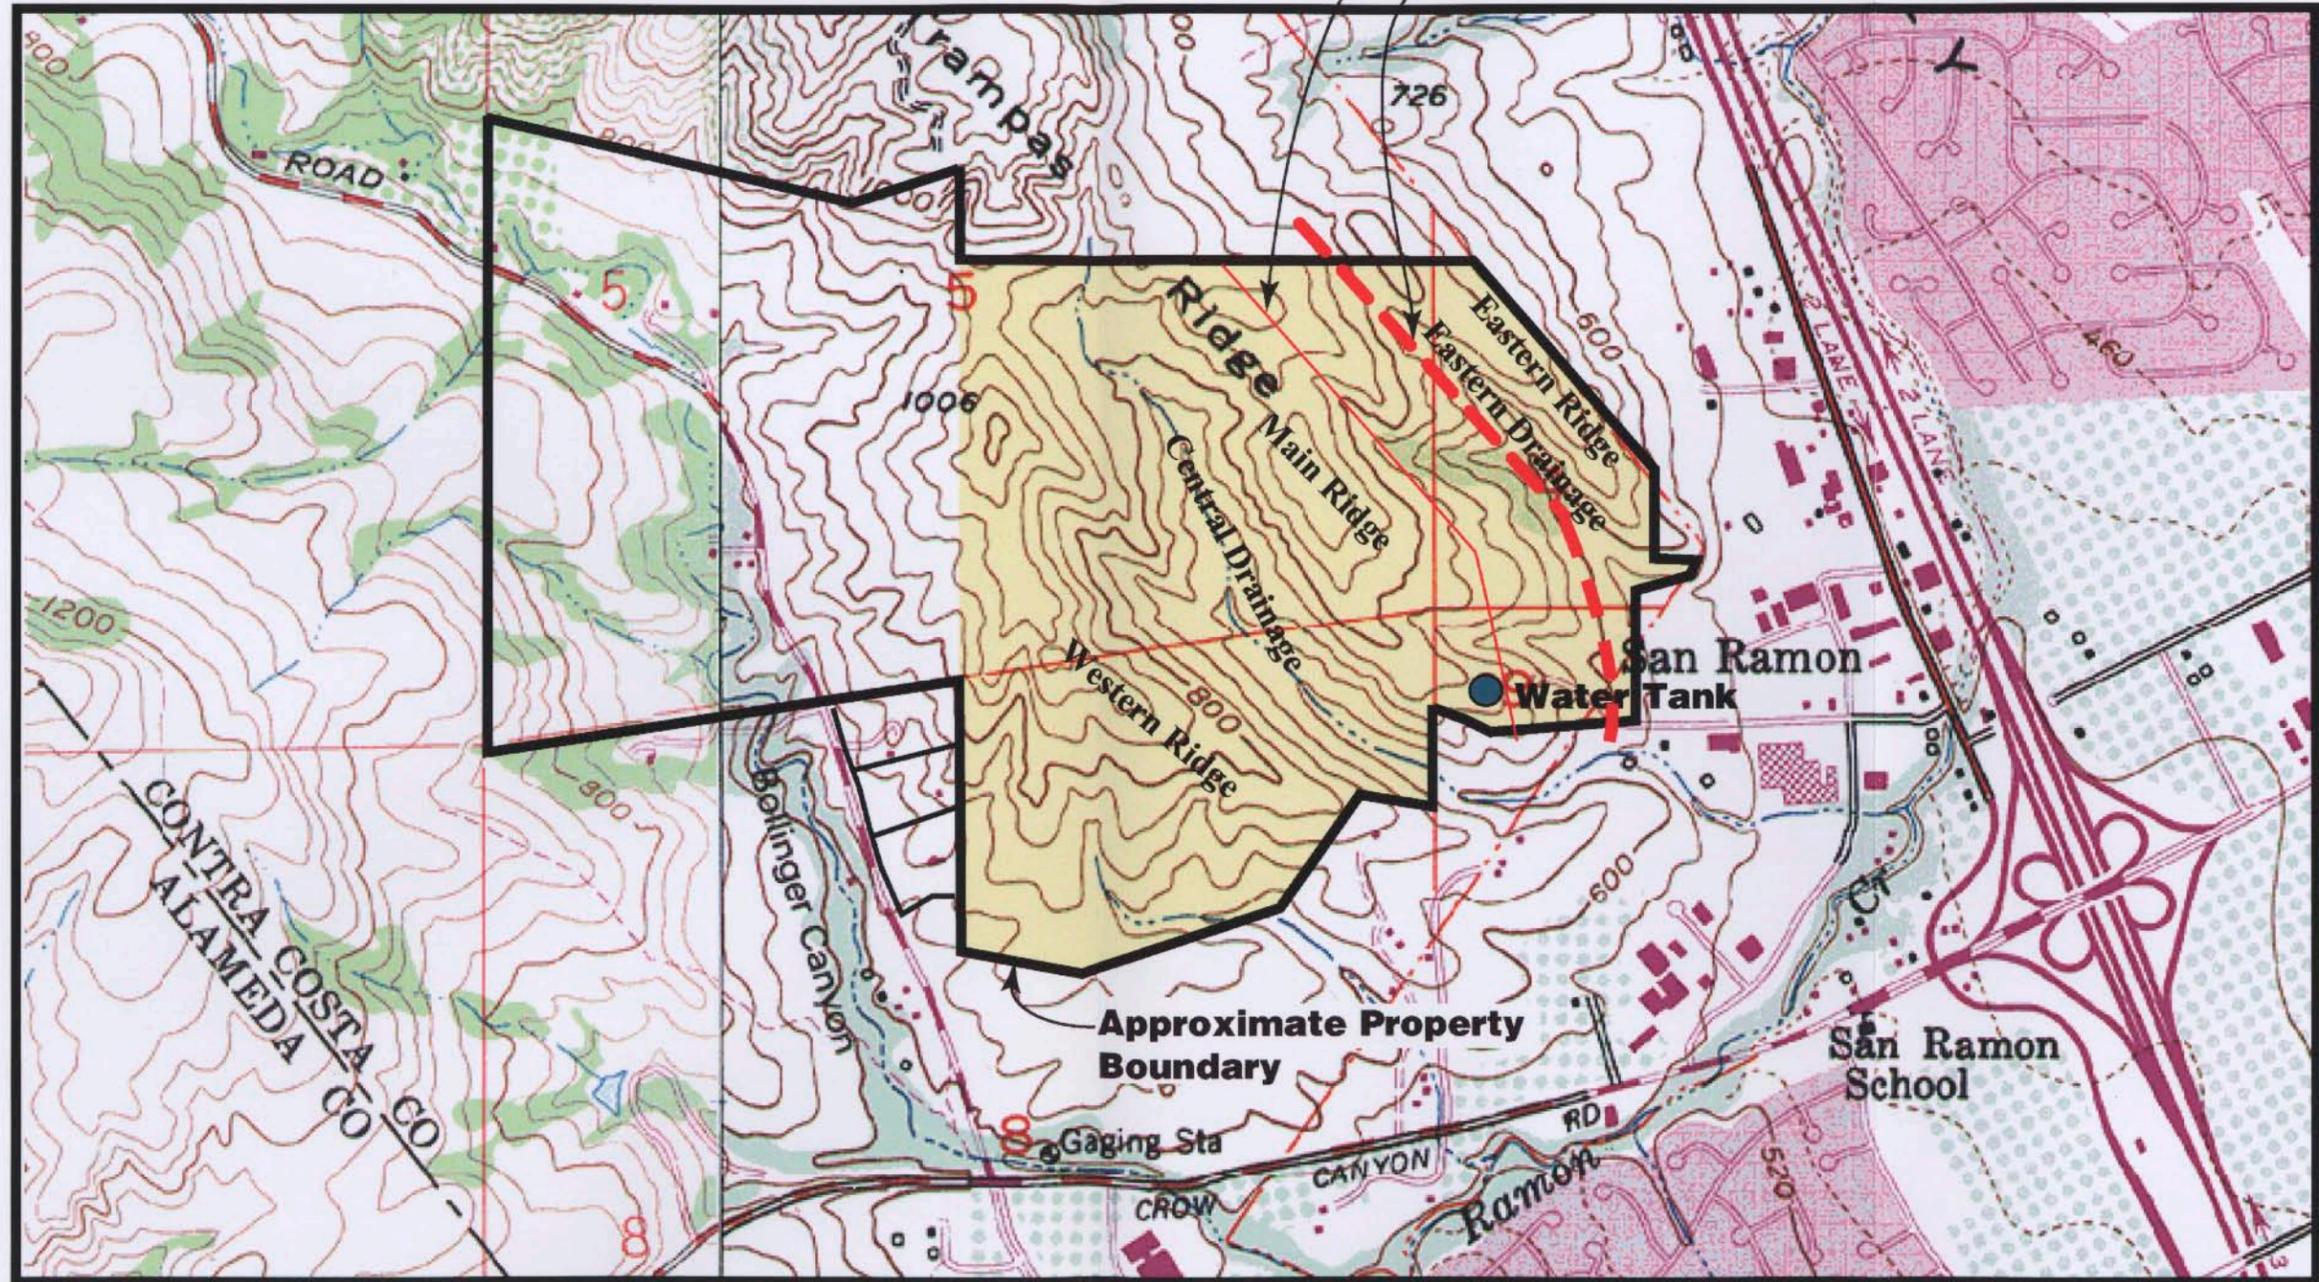
<b>Earth Systems Consultants</b> Northern California	Lands of Faria San Ramon, California	<b>STUDY AREA</b>	
		Date: October 2004 File No: FRG-3379-03	Figure 2

**Approximate Fault Hazard Zone West Boundary**  
**Mapped Calaveras Fault Location**

**Study Area (This Report)**
